Heliyon 2 (2016) e00154

Potential tree species for use in urban areas in temperate and oceanic climates

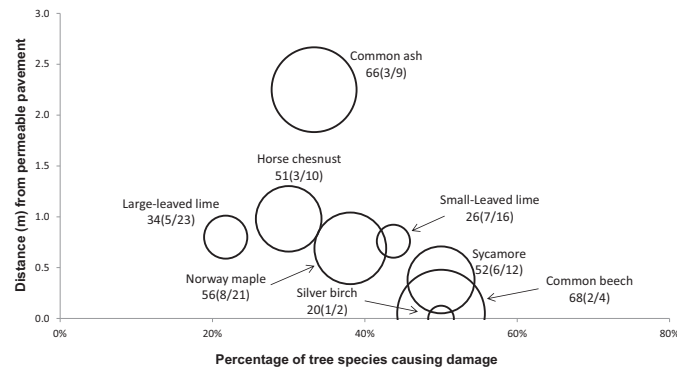
For x(y/z), where x represents the DBH (cm), which is also signified by the relative size (diameter) of the circle. The diameters expressed by circles give a visual indication of the maturity of the average tree species, which makes visual comparisons between trees easier. The entry z indicates the number of the tree species within 10 m of the structure, out of which y trees caused moderate to severe damage.

Fig. 2. Relationships of tree diameters at breast height (DBH (cm); represented by circles), average distances of trees away from permeable pavements, and the proportion of trees within 10 m to these structures subjected to moderate to severe damage. Note: $x(y/z)$, where x represents DBH and z indicates the number of the tree species out of which y trees caused damage.

Fig. 2, Fig. 3, Fig. 4, Fig. 5, Fig. 6, Fig. 7, Fig. 8 show the relationship of tree DBH, average distance of trees away from the structures, and the proportion of trees close to structures that caused moderate to severe damage. Note that only moderate and severe damage was considered, considering that the reason for light damage is often unclear. Apart from tree-related damage, other reasons for damage might be as important but only further destructive tests on site might reveal the main reason(s) for damage.

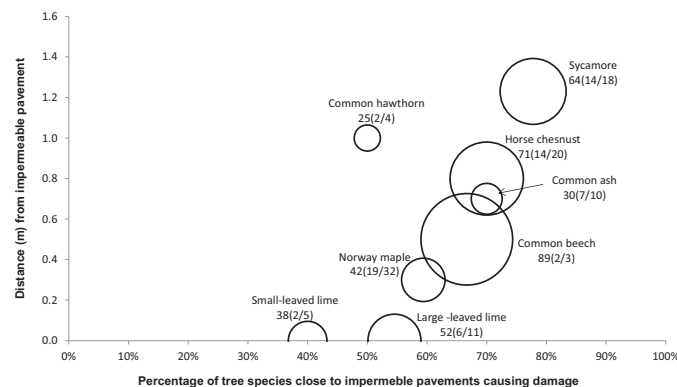
Fig. 3. Relationships of tree diameters at breast height (DBH (cm); represented by circles), average distances of trees away from impermeable pavements, and the proportion of trees within 10 m to this structure subjected to moderate to severe damage. Note: $x(y/z)$, where x represents DBH and z indicates the number of the tree species out of which y trees caused damage.

For permeable pavements, most significant ($p < 0.05$) damage to permeable pavements was caused by trees located within 0–1.0 m away from a structure, except for those from *F. excelsior*. About 33% of *F. excelsior* located close to permeable pavements caused damage to these pavements if their average diameter was 66 cm and if their average distance was 2.3 m away from the permeable pavements (Fig. 2). The trees with the highest percentage of moderate and severe damage to permeable pavements (up to 50%) were *F. sylvatica*, *A. pseudoplatanus* and *B. pendula*. However, the corresponding sample sizes were rather small. The average distance of *F. sylvatica* and *B. pendula* to permeable pavements was 0 m, indicating that most of these two species were planted too close to the pavement. The average DBH of these trees was 68 cm and 20 cm, respectively (Fig. 3).

For an impermeable pavement, the further away the tree (up to a distance of 1.4 m), the higher is the percentage of this tree causing damage irrespective of the tree DBH (Fig. 3). This is rather unexpected, considering that a large tree DBH is usually linked to large roots, which would cause damage at close range. However, the tree DBH variability is relatively small and the sample sizes are rather small as well. Regression analysis did not reveal any significant findings.

This study revealed that the pavements of Greater Manchester roads consist of more impermeable pavements than permeable pavements. Considering the findings of [Morgenroth \(2011\)](#) and [Viswanathan et al. \(2011\)](#), the Greater Manchester case is more likely linked to the phenomenon of insufficient moisture in the compacted soil strata below the impermeable pavements, and the tendency of roots to remain close to the surface for oxygen and moisture availability. Hence, this is the reason for greater damage to impermeable pavements than permeable pavements. This phenomenon seems common where there are more impermeable pavements than porous surfaces. *Acer pseudoplatanus* caused the most damage to impermeable pavements (78%) from an average distance of 1.3 m and an average DBH of 64 cm.

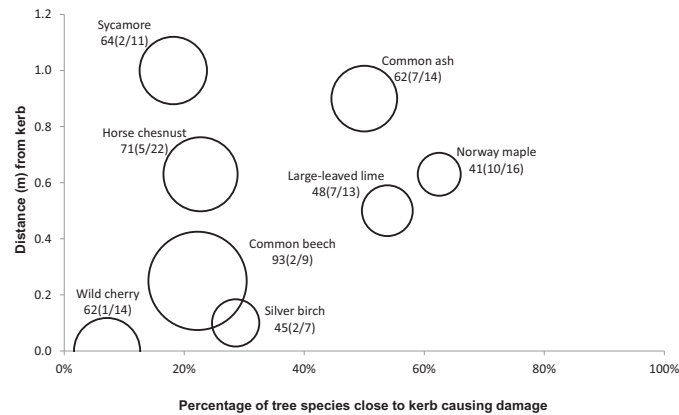
Fig. 4. Relationships of tree diameters at breast height (DBH (cm); represented by circles), average distances of trees away from kerbs, and the proportion of trees within 10 m to these structures subjected to moderate to severe damage. Note: x(y/z), where x represents DBH and z indicates the number of the tree species out of which y trees caused damage.

Kerb damage comprised 19% of all recorded structural damage. *Acer platanoides* caused the most damage to kerbs (10 out of 16 trees were located close to kerbs) from an average distance of 0.6 m and with a mean DBH of 41 cm ([Fig. 4](#)). Similar to *A. platanoides* was the impact of *T. platyphyllos* (7 out of 13 nearby *T. platyphyllos*), *A. pseudoplatanus* (2 out of 11 surrounding trees) and *F. excelsior* (7 out of 14 surrounding trees) caused damage to kerbs from the furthest average distance of 1 m ([Fig. 4](#)).

Other trees that caused damage were less than 1 m from the kerb as shown in [Fig. 4](#). *Prunus avium* was the best tree suitable for kerbs: only 1 in 14 trees caused moderate to severe damage ([Fig. 4](#)). However, most *P. avium* were very closely located (0 m) to kerbs, and their average DBH was 62 cm. This was closely followed by *F. sylvatica*. Although for *F. sylvatica* of an average DBH of 93 cm (indicating trees well-advanced in age) and an average distance of 0.23 m from kerbs, only 2 out of 9 trees caused moderate to severe damage to kerbs ([Fig. 4](#)). The worst tree to be located close to kerbs is *A. platanoides*. For trees of this species with an average DBH of 41 cm (indicating middle age) and located about 0.6 m from the kerbs, about 10 out of 16 *A. platanoides* caused moderate to severe damage to kerbs ([Fig. 4](#)).

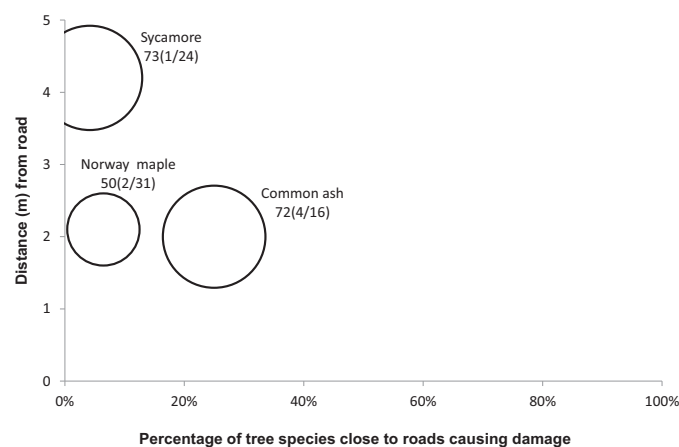
Fig. 5. Relationships of tree diameters at breast height (DBH (cm); represented by circles), average distances of trees away from roads, and the proportion of trees within 10 m to these structures subjected to moderate to severe damage. Note: x(y/z), where x represents DBH and z indicates the number of the tree species out of which y trees caused damage.

The percentages of damage to roads and retaining walls were 3% each. Only three trees (*F. excelsior*, *A. platanoides* and *A. pseudoplatanus*) caused moderate to severe damage to roads ([Fig. 5](#)). Trees that caused damage to roads were located within an average distance of 2–5 m away from roads, indicating that the majority of them were planted close to the pavements.

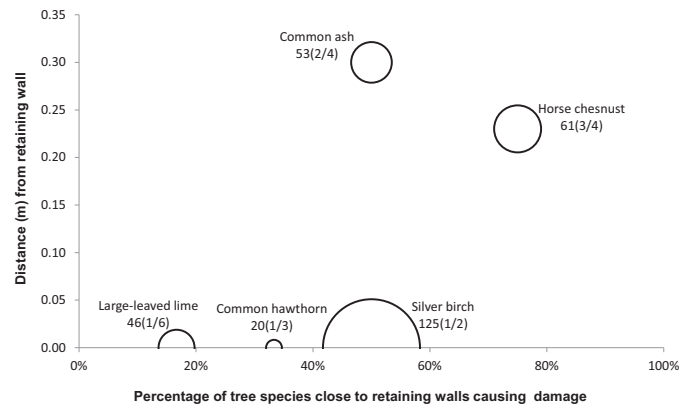
Fig. 6. Relationships of tree diameters at breast height (DBH (cm); represented by circles), average distances of trees away from retaining walls, and the proportion of trees within 10 m to these structures subjected to moderate to severe damage. Note: x(y/z), where x represents DBH and z indicates the number of the tree species out of which y trees caused damage.

Not many trees were found close to retaining walls. For *B. pendula* with a DBH of 125 cm and planted at an average distance to structures of close to 0 m, only 1 out of 2 trees caused moderate to severe damage ([Fig. 6](#)). *Aesculus hippocastanum*

caused the most damage to retaining walls. Three out of four *A. hippocastanum* with an average DBH of 61 cm and located at a mean distance of 0.25 m away caused moderate to severe damage to retaining walls (Fig. 6).

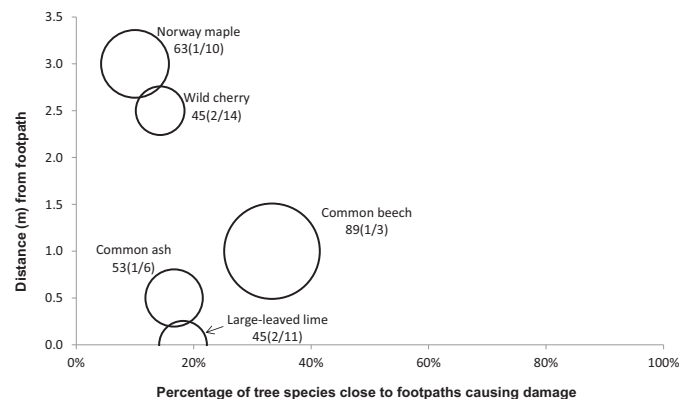
Fig. 7. Relationships of tree diameters at breast height (DBH (cm); represented by circles), average distances of trees away from footpaths, and the proportion of trees within 10 m to these structures subjected to moderate to severe damage. Note: x(y/z), where x represents DBH and z indicates the number of the tree species out of which y trees caused damage.

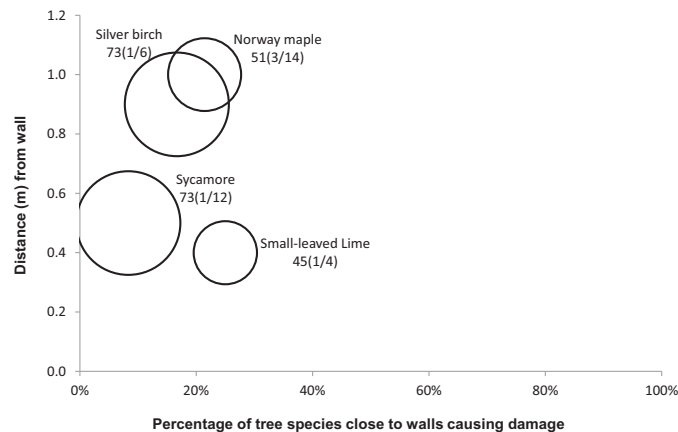
Fig. 8. Relationships of tree diameters at breast height (DBH (cm); represented by circles), average distances of trees away from walls, and the proportion of trees within 10 m to these structures subjected to moderate to severe damage. Note: $x(y/z)$, where x represents DBH and z indicates the number of the tree species out of which y trees caused damage.
